2019 Annual Monitoring Report for the North Platte River Restoration Project

Joanna Harter, Aquatic Habitat Project Biologist, Wyoming Game and Fish Department, 5400 Bishop Blvd, Cheyenne, WY 82006

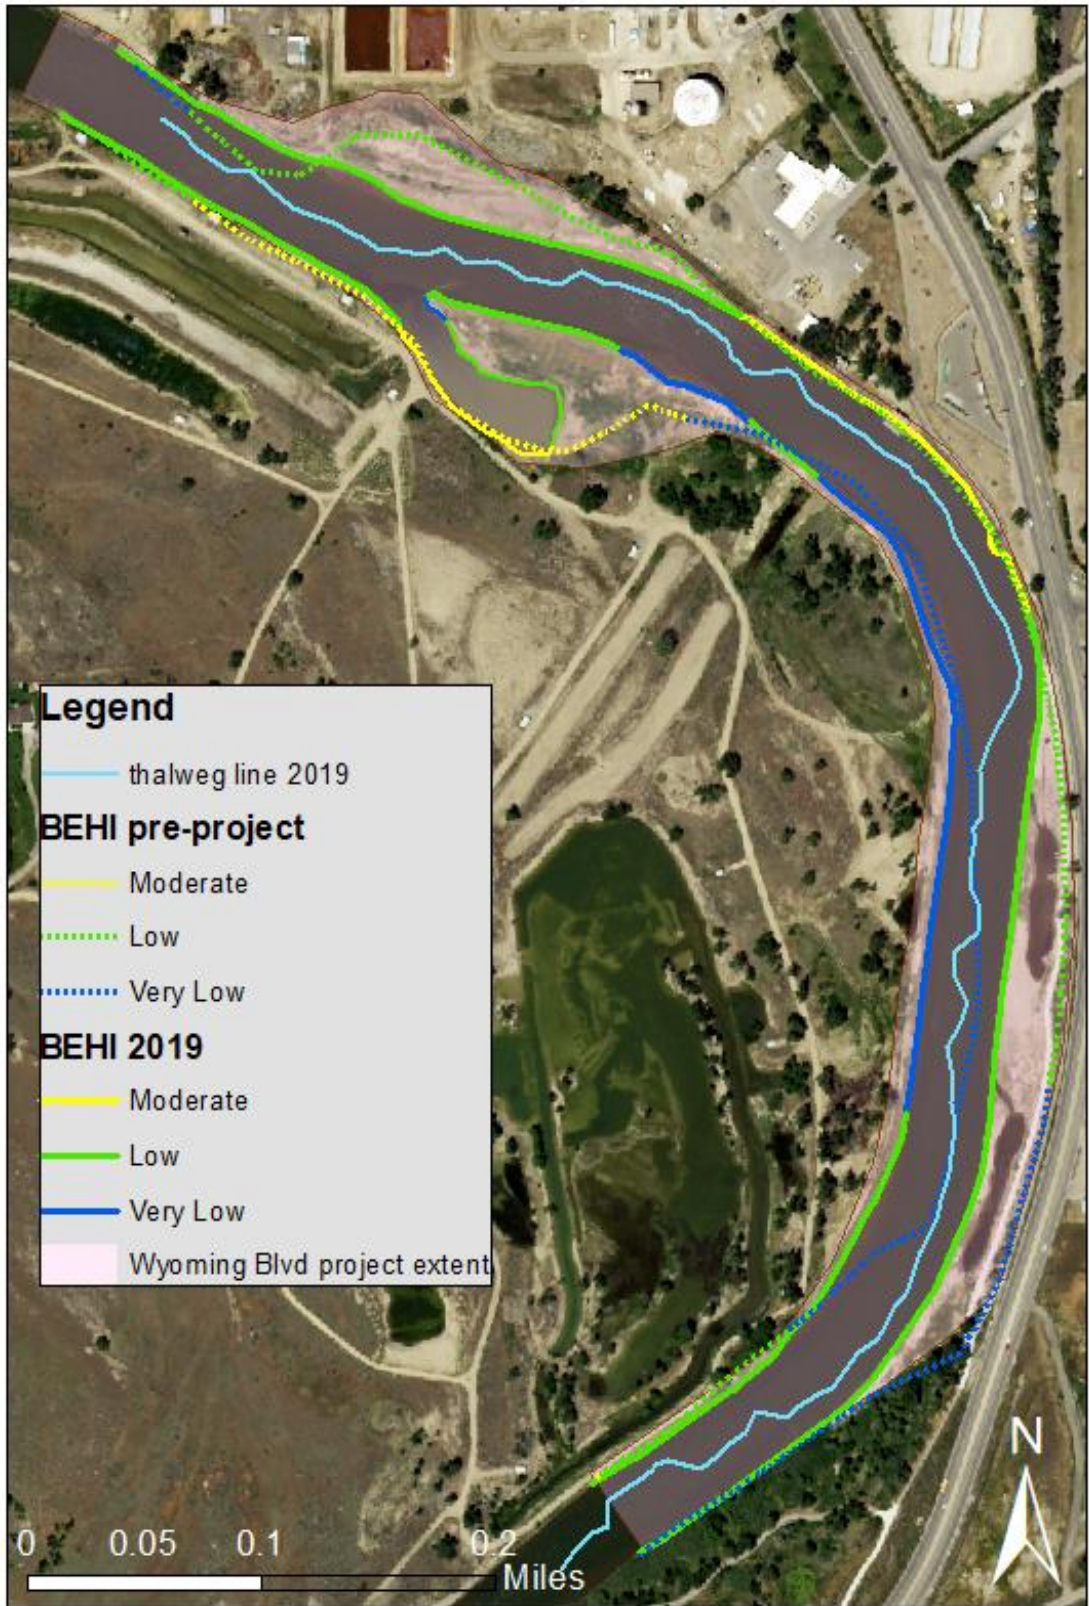
BEHI and NBS ratings were mapped (Figures 8-9) and summarized in Table 6. The goal was for BEHI and NBS to be moderate, low, or very low on all banks within the project reach. In 2019, BEHI was low or very low on 90% of the bank length and moderate on 10% of the bank length (Table 6). No banks received a BEHI rating greater than moderate in 2019. The biggest difference in 2019, was the greater percentage (70% vs 43%) of the bank length with a “low” rating and a smaller percentage (20% vs. 43%) with a “very low” rating, compared to pre-construction BEHI values. This is likely not indicative of a trend in bank erosion risk, but rather due to differences in the individual observers who rated the banks in each year. The bank on river right that received a moderate BEHI rating was not modified during the restoration project because it supported important infrastructure that was left undisturbed. An oxbow wetland was created at the downstream end of the project reach and, because this wetland is connected to the main channel even at base flows, we rated the banks for BEHI as well. The oxbow wetland stream banks were not included in Table 6 because it would confound evaluation of erosion risk of stream banks along the main channel. Of the oxbow wetland banks, 52% received a low or very low BEHI rating and 48% received a moderate rating. The bank in the oxbow wetland with the moderate rating was not modified during restoration because it supports a road and serves as a barrier to water treatment plant ponds.

FIGURE 8. Bank Erosion Hazard Index (BEHI) ratings for the banks in the Wyoming Blvd project reach before restoration (dotted) and after restoration (solid lines).

- As coir fabric deteriorates over the next couple years, banks will become more exposed to erosive forces of the stream flow, especially where riparian vegetation has not established. The lower half of the Wyoming Blvd reach should be closely monitored to determine if additional plantings are needed to maintain bank stability. The loss of coir fabric will also likely result in lower BEHI ratings, as coir fabric was counted as surface protection in BEHI ratings in 2019.

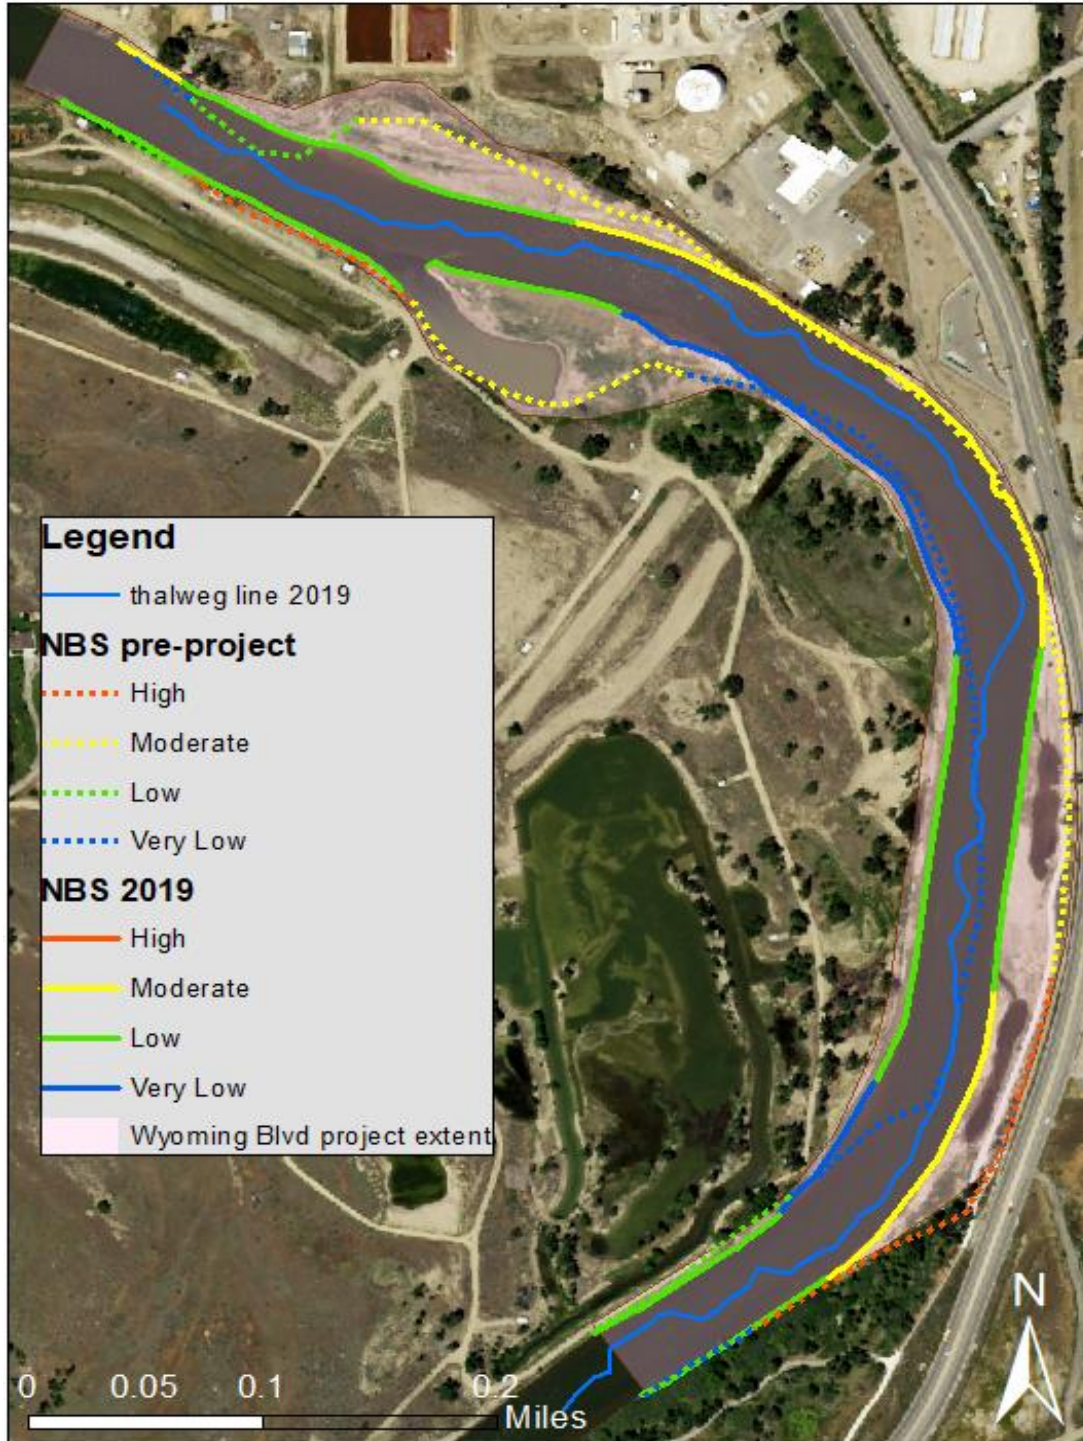
FIGURE 9. Near-Bank Stress (NBS) ratings for the banks in the Wyoming Blvd project reach before restoration (dotted) and after restoration (solid lines).

In 2019, NBS ratings were low or very low on 73% of the banks (Table 6). Moderate NBS ratings were assigned to two bank segments, both on outside bends along Wyoming Boulevard (Figure 9). However, neither of these banks are concerning. At the upstream bank, where the new floodplain was created, willows and cottonwoods have established well and

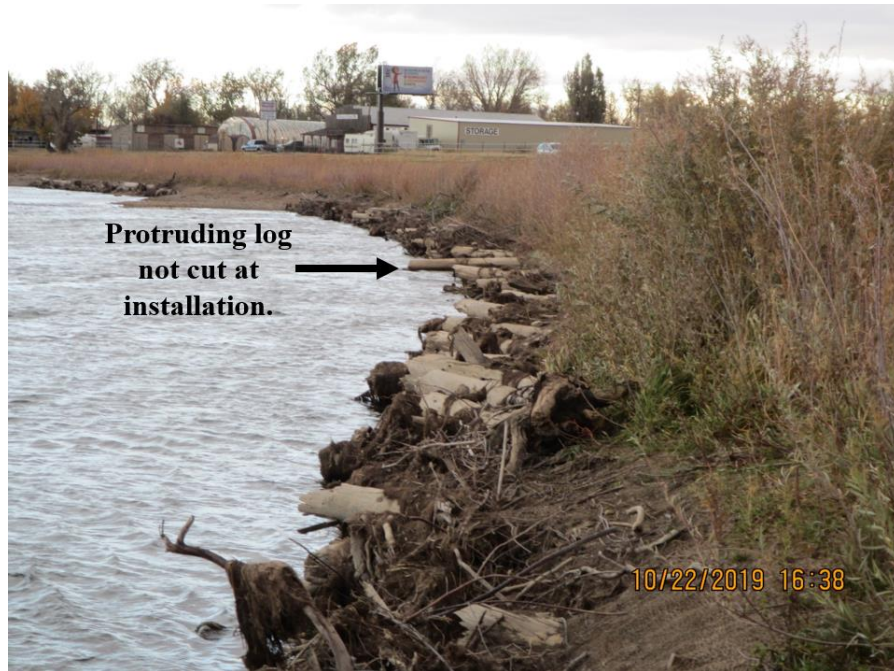
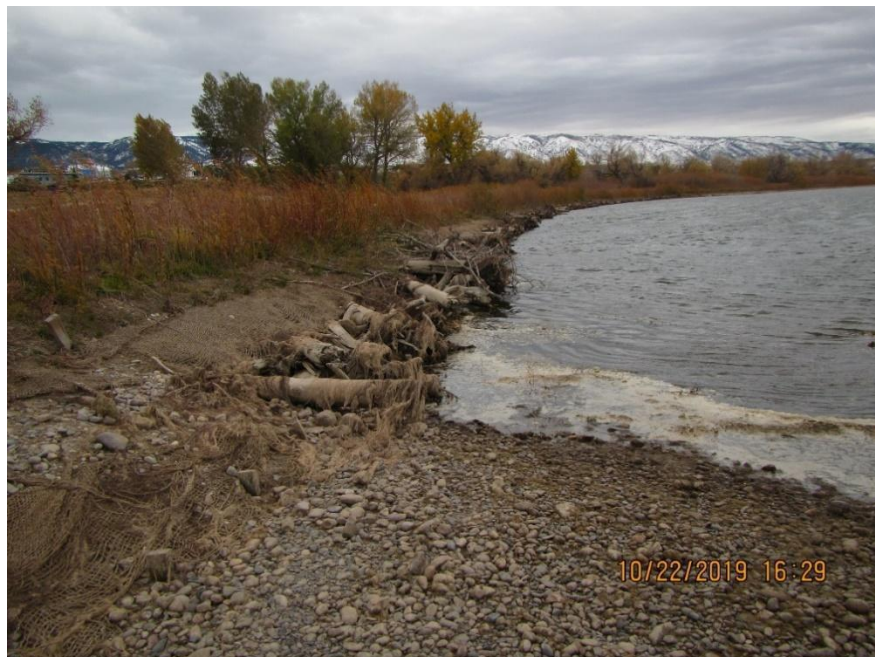
FIGURE A.5.2. Site 2 & 3 - Wyoming Blvd, standing at downstream end of toe wood 1, looking upstream. Willows have established well above the structure, contributing to long-term bank stability.

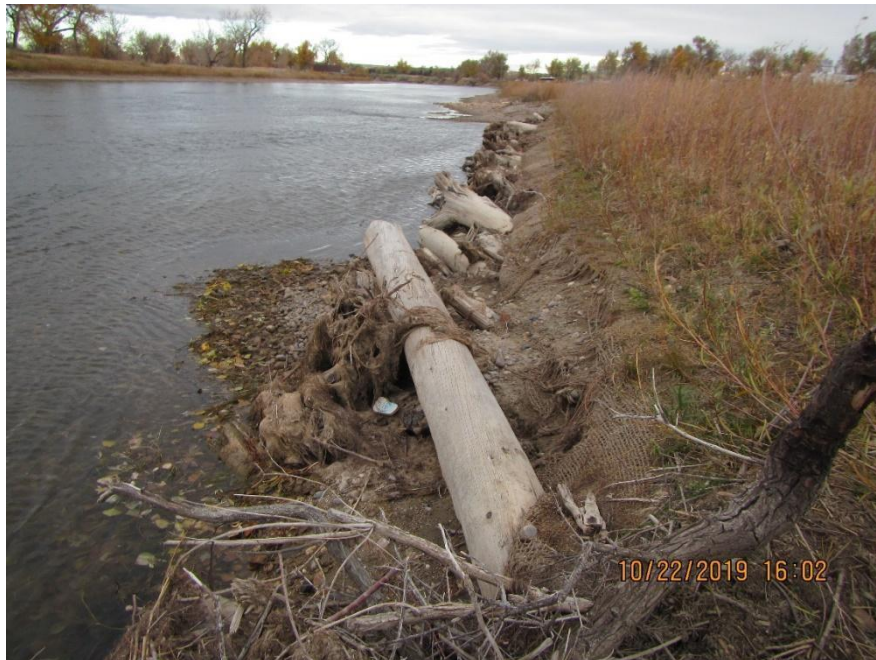
FIGURE A.5.3. Site 2 & 3 - Wyoming Blvd, standing upstream of toe wood 2, looking downstream.

Toe wood 2 is approximately 115 ft long, located just downstream of toe wood 1 and upstream of the first set of wetland outlet cross vanes (Figures A.5.3, A.5.4). Localized bank scour was observed around multiple logs in this structure, resulting in more log length being exposed. Toe wood 2 should continue to be monitored closely for further signs of bank erosion between the vegetation line and the root wads, especially as coir fabric deteriorates. Young willows have established well above the structure. Toe wood 2 is not providing much fish cover or habitat as the root wads were elevated above the water surface elevation at base flows in both 2018 and 2019 and there was no pool being maintained along the structure. The elevation difference between the tops of the root wads or logs and the water surface at base flow ranged from 1.5 to 3.0 ft, with an average of 2.1 ft.

The third geomorphic goal was to stabilize stream banks. Excessive bank erosion was not evident in the Wyoming Blvd reach. Toe wood was largely intact and functioning to protect constructed banks. At toe wood 2 and 3 the bank should continue to be closely monitored for signs of slumping and erosion in locations where root wads appear missing or have larger gaps.

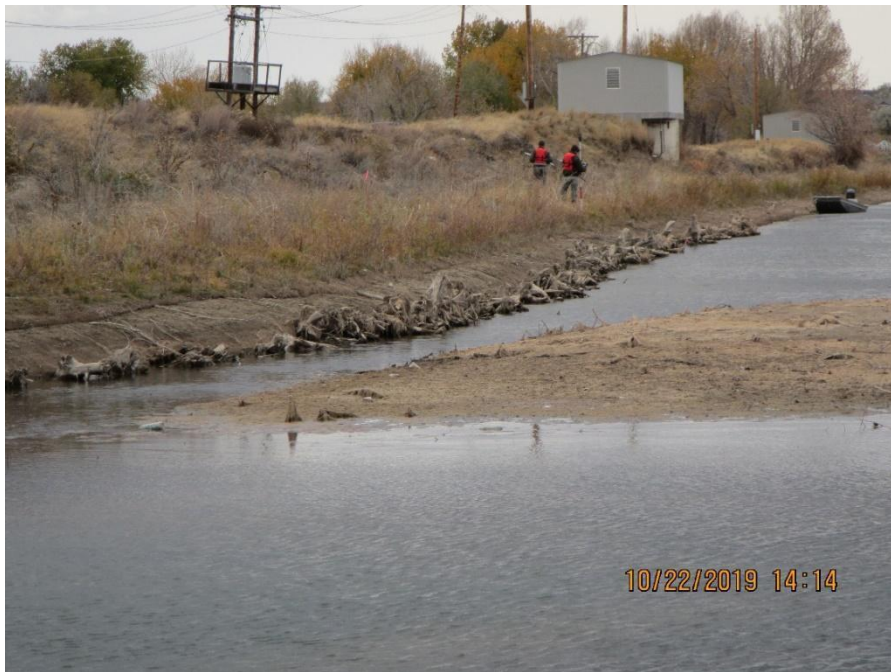
FIGURE A.5.9. Site 2 & 3 - Wyoming Blvd, standing near upstream end of toe wood 5, looking downstream.

Toe wood 5 is approximately 345 ft long, located on the left bank, just downstream of the oxbow wetland (Figures A.5.9, A.5.10). This structure was not in the 100% design plans but was constructed to provide extra protection for the streambank along the water treatment facility wells (T.C. Dinkins, Stantec Design Engineer, personal communication). The river bends right at this location, which likely places additional shear stress on the left bank. Rock vanes 4 and 5 help direct channel flows into the center, rather than this outside bend. Fine sediment deposition was observed just below and between the root wads, likely due to sediment settling out of the slower water downstream of the oxbow wetland. A sediment bar is also forming at the mouth of the oxbow wetland, indicating that the bank is not experiencing high shear stress. The oxbow wetland was intended to be more isolated from the main channel than it currently is, so the deposition is acceptable (T.C. Dinkins, Stantec Design Engineer, personal communication). Some willows have begun to establish above the toe wood, but not as densely as above the first three toe wood structures.

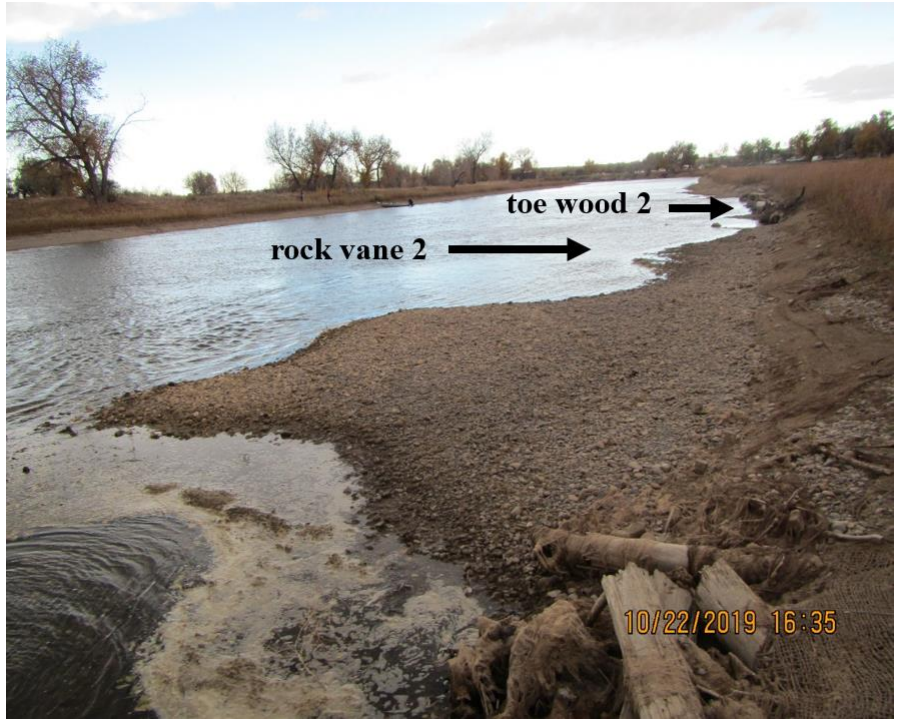
Rock vane 2 is located upstream of toe wood 2 (Figure A.5.12). In 2019, only one small boulder could be visually identified. Rock vane 2 received a “damaged” rating for structural integrity and a “4” rating for deposition because over 75% of the structure was buried. A pool was maintained upstream of the structure and toward the middle of the channel. This may be contributing to deposition upstream of rock vane 2. This may not be an ideal structure and location combination, as they tend to become aggraded. The vane was intended to help transition out of a pool and into a riffle and the structure might not have been necessary (T.C. Dinkins, Stantec Design Engineer, personal communication).

FIGURE A.5.12. Site 2 & 3 - Wyoming Blvd, standing just upstream of rock vane 2 on river right, looking downstream at rock vane 2 (rocks not visible in photo).

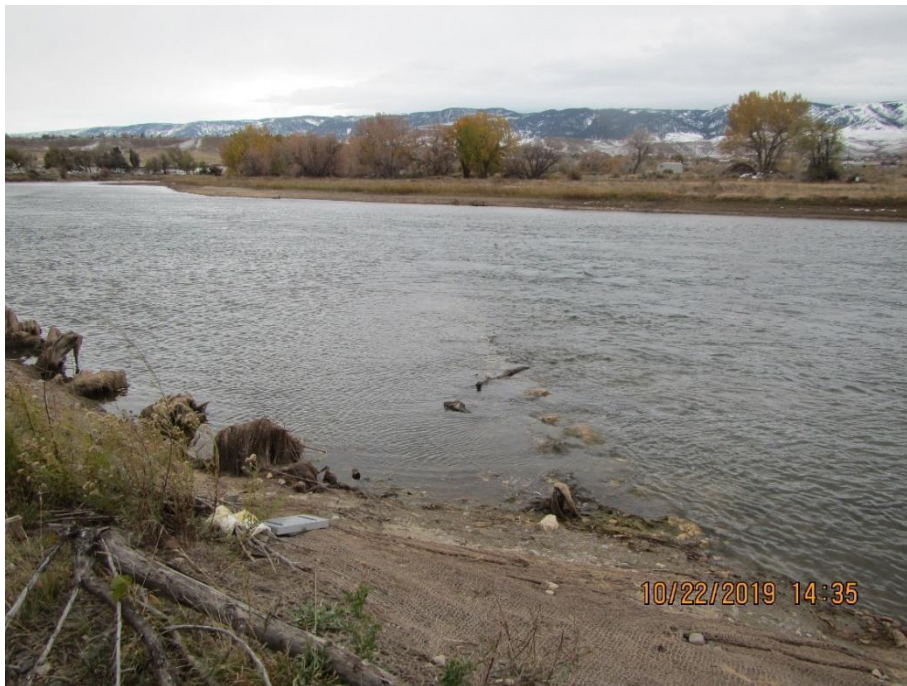
Rock vane 4 is located just downstream of toe wood 4 and was not in the 100% design plans (Figures A.5.14, A.5.15). Rock vane 4 spans over half of the channel width at base flow. Two boulders in the vane (the 21st and 22nd from the bank) rolled downstream 2-3 ft. A deep, well-defined pool is maintained downstream of the structure. Thus, rock vane 4 received an “intact” rating for structural integrity, as the shifted boulders do not comprise 10% of the structure, and a “0” rating for erosion/deposition, as none was observed.

FIGURE A.5.14. Site 2 & 3 - Wyoming Blvd, standing at rock vane 4 on river right, looking slightly upstream, in direction of rock vane 4. Boulders in the vane are visible near the bank.

FIGURE A.5.15. Site 2 & 3 - Wyoming Blvd, standing just upstream of rock vane 4 on river right, looking slightly downstream, in direction of rock vane 4. The vane's influence on streamflow is visible at these flows past the channel center.

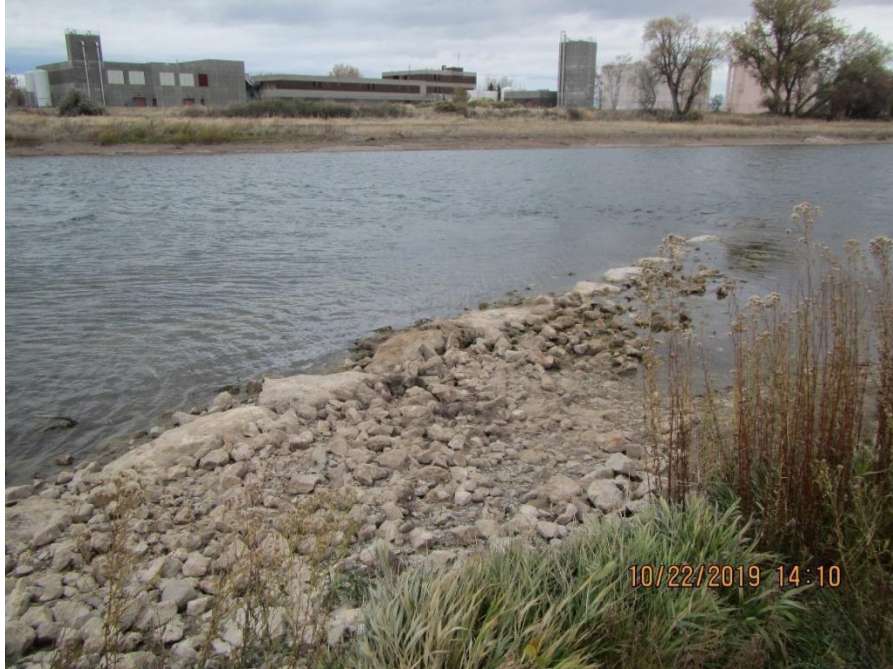
FIGURE A.5.16. Site 2 & 3 - Wyoming Blvd, standing upstream of rock vane 5 on river left, looking downstream, in at rock vane 5.

Rock vane 5 is located just upstream of toe wood 5 and upstream of the mouth of the oxbow wetland (A.5.16, A.5.17). Rock vane 5 was also not in the 100% design plans but was added in conjunction with toe wood 5 to protect infrastructure on the left bank. Most boulders in this vane were visible and in place in 2019 so it received an “intact” rating for structural integrity and a “0” rating for erosion/deposition as none was observed.
