2019 Annual Monitoring Report for the North Platte River Restoration Project

Joanna Harter, Aquatic Habitat Project Biologist, Wyoming Game and Fish Department, 5400 Bishop Blvd, Cheyenne, WY 82006

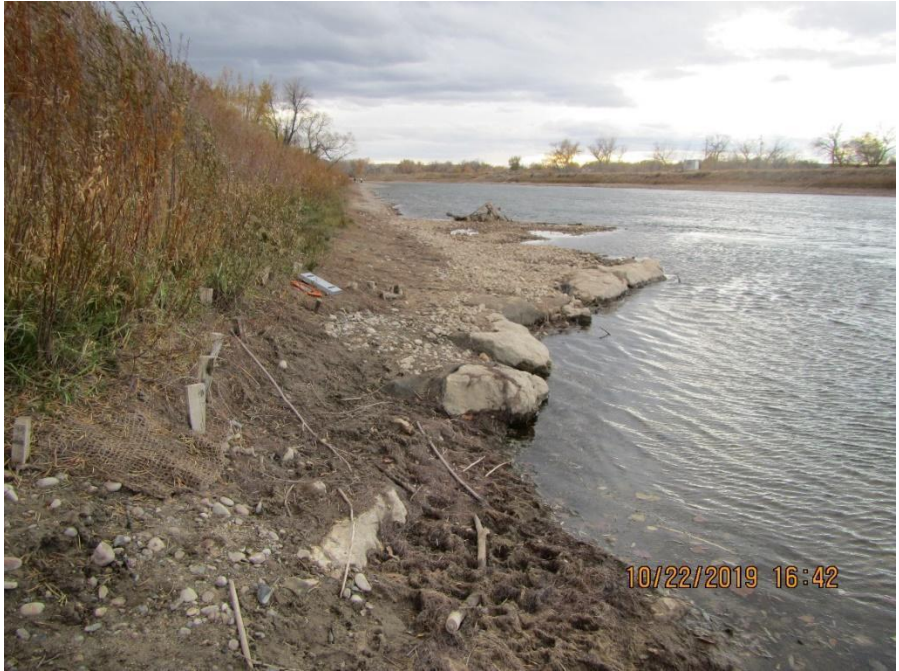
Rock vanes and riffle vanes largely continue to function to direct flows toward the channel center. However, several of the vanes had “damaged” structural integrity ratings and higher erosion/deposition ratings than desired. In several of the rock vanes, boulders had been buried and some individual boulders had rolled out of place. These structures should continue to be monitored to determine if the deposition is significantly affecting their function.

FIGURE A.5.11. Site 2 & 3 - Wyoming Blvd, standing downstream of rock vane 1 on river right, looking upstream.

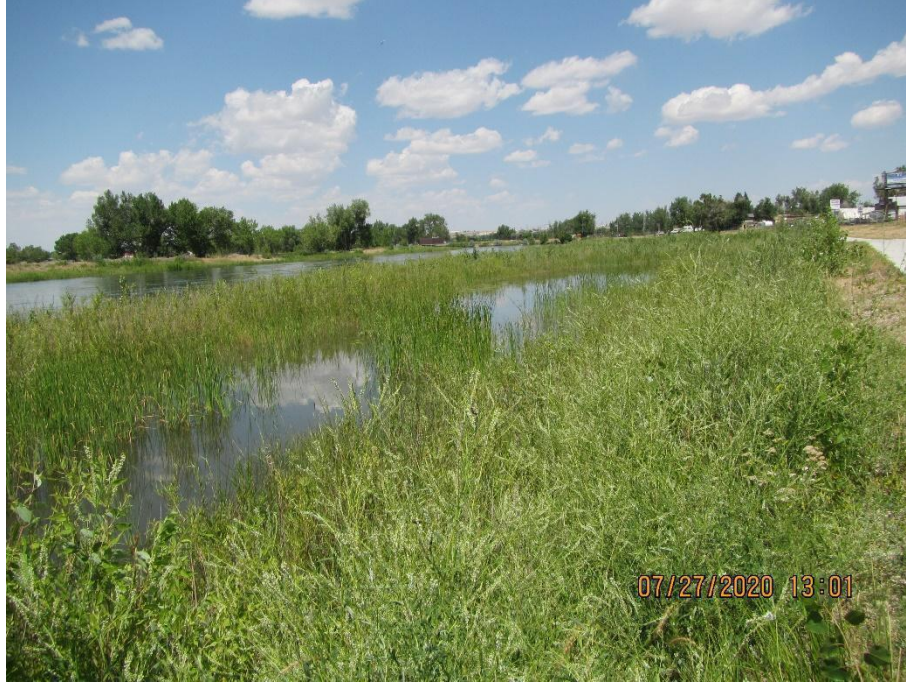
FIGURE A.5.19. Site 2 & 3 - Wyoming Blvd, at middle of upstream wetland along Wyoming Boulevard, looking downstream.

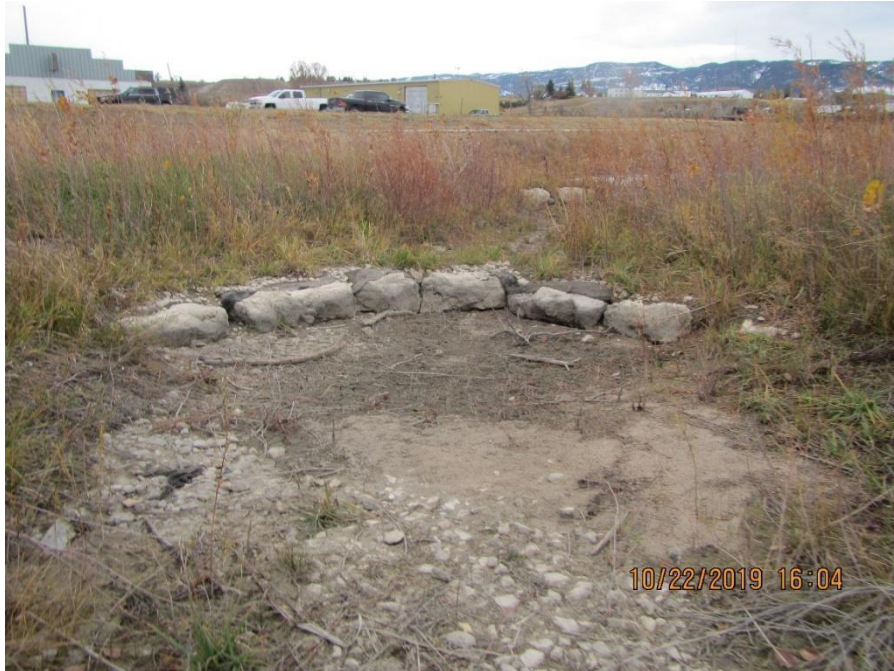
FIGURE A.5.21. Site 2 & 3 - Wyoming Blvd, at upstream set of wetland cross vanes, looking at cross vane 38.

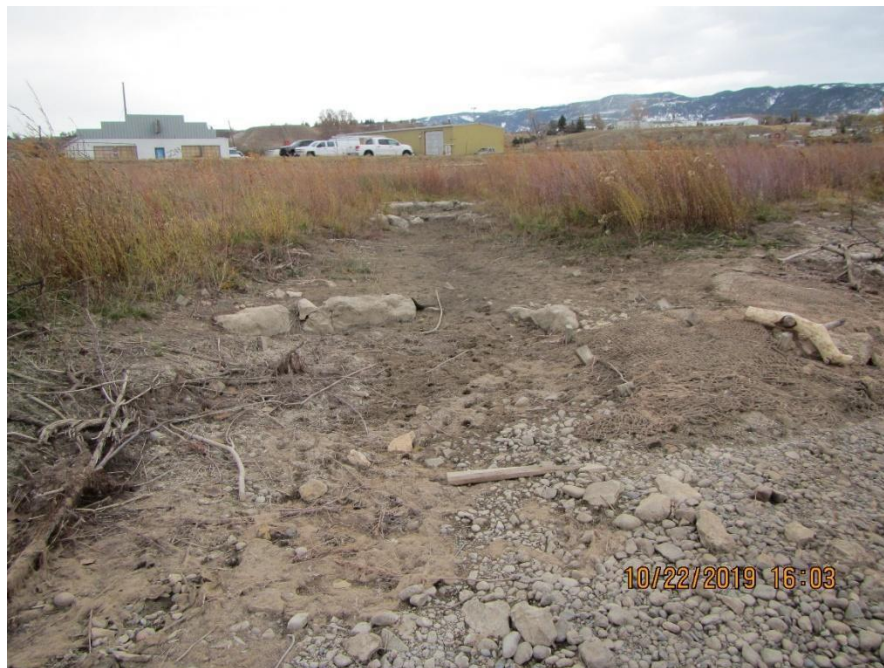
FIGURE A.5.22. Site 2 & 3 - Wyoming Blvd, at upstream set of wetland cross vanes, looking at cross vanes 39A (middle) and 39B (closest). Cross vane 38 is also visible (furthest).

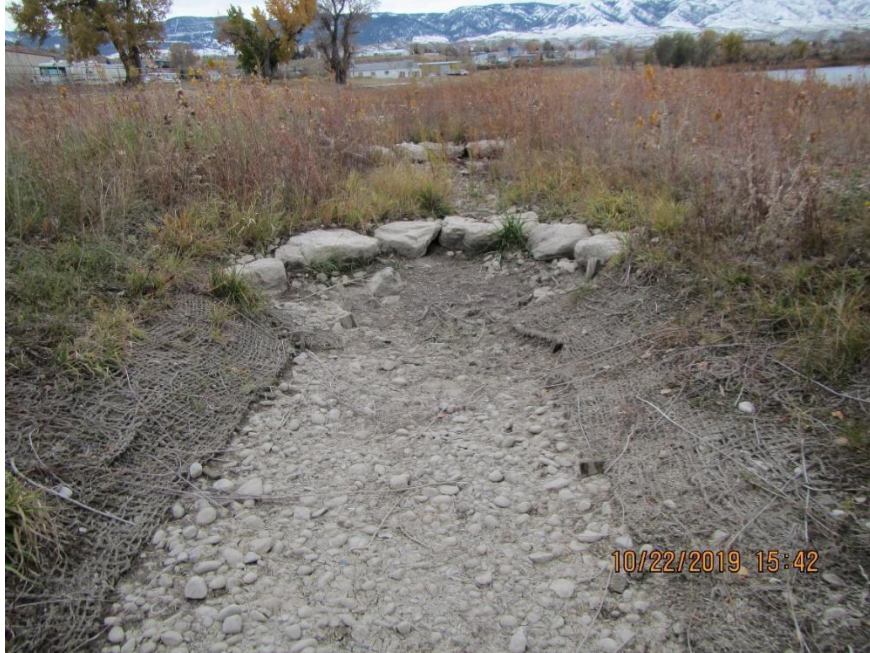
FIGURE A.5.25. Site 2 & 3 - Wyoming Blvd, at downstream set of wetland cross vanes, looking up at cross vane 41.
