2019 Annual Monitoring Report for the North Platte River Restoration Project

Joanna Harter, Aquatic Habitat Project Biologist, Wyoming Game and Fish Department, 5400 Bishop Blvd, Cheyenne, WY 82006

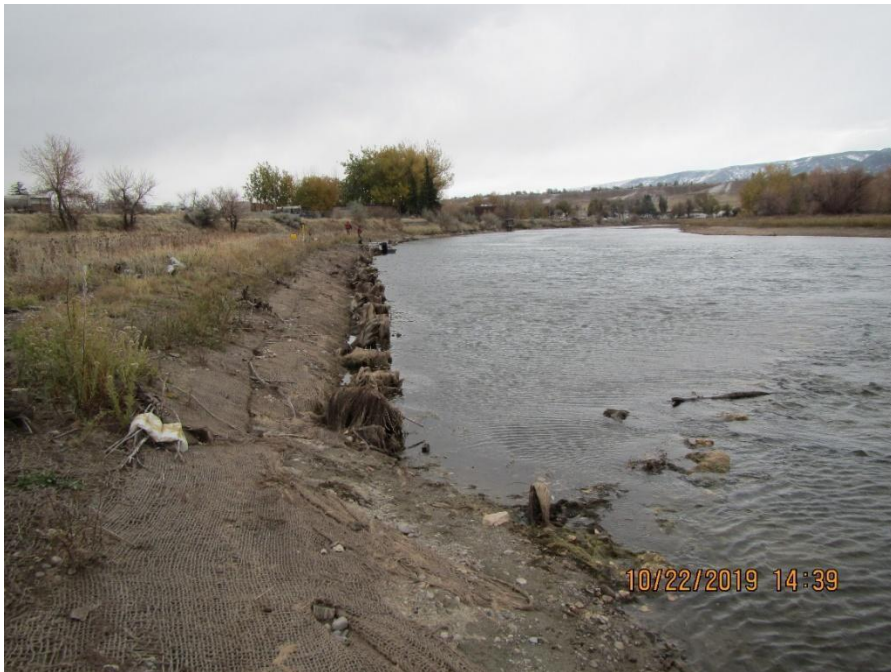
The third geomorphic goal was to stabilize stream banks. Excessive bank erosion was not evident in the Wyoming Blvd reach. Toe wood was largely intact and functioning to protect constructed banks. At toe wood 2 and 3 the bank should continue to be closely monitored for signs of slumping and erosion in locations where root wads appear missing or have larger gaps.

FIGURE A.5.8. Site 2 & 3 - Wyoming Blvd, standing downstream of toe wood 4, looking upstream at toe wood 4.

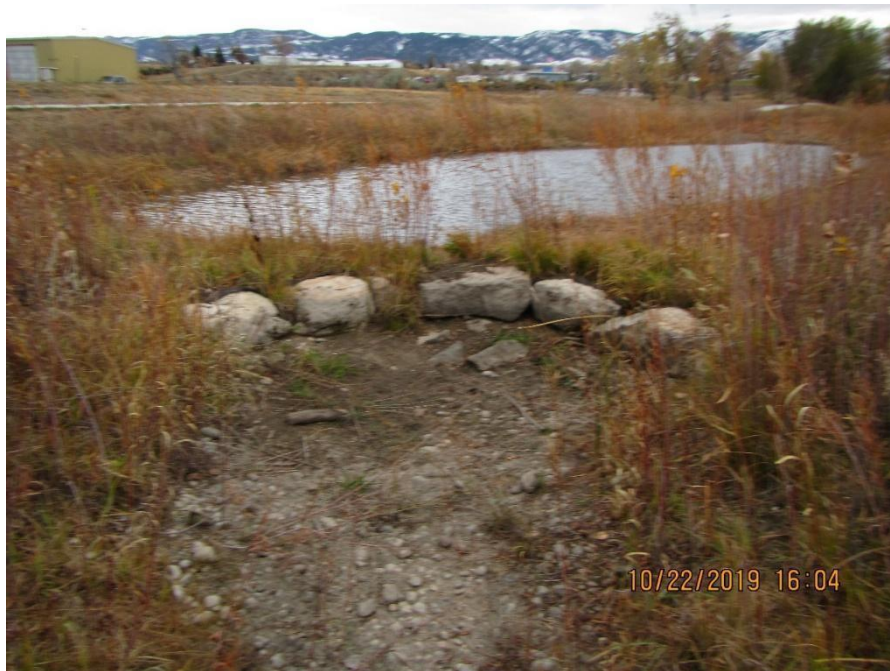
FIGURE A.5.20. Site 2 & 3 - Wyoming Blvd, at upstream set of wetland cross vanes, looking at cross vane 37.

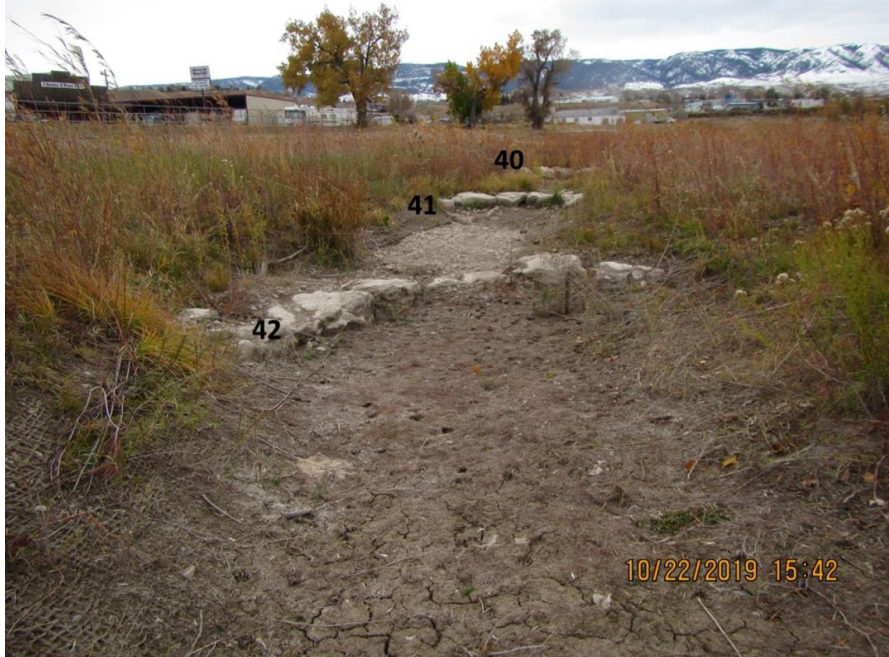
FIGURE A.5.23. Site 2 & 3 - Wyoming Blvd, at downstream set of wetland cross vanes, looking up at cross vanes 40,41, and 42.

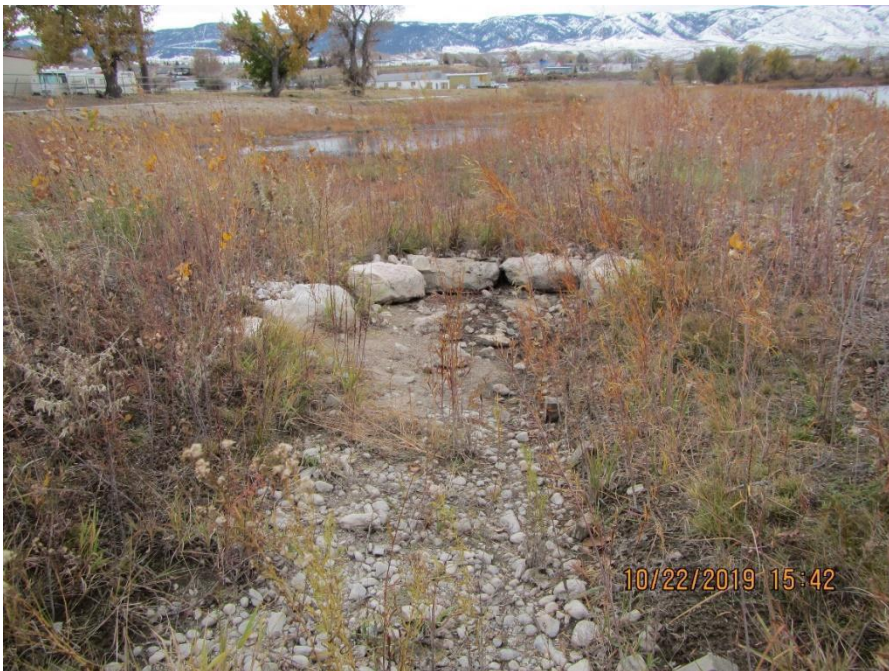
FIGURE A.5.24. Site 2 & 3 - Wyoming Blvd, at downstream set of wetland cross vanes, looking up at cross vane 40.
